BYG R-455
March 2021

Measuring report Stengården

The report describes the monitoring system and the measurements for the PVT-E system installed in the row house in Stengården, Denmark. The system consists of a new roof design with PV and PVT panels connected to a battery and a heat pump.

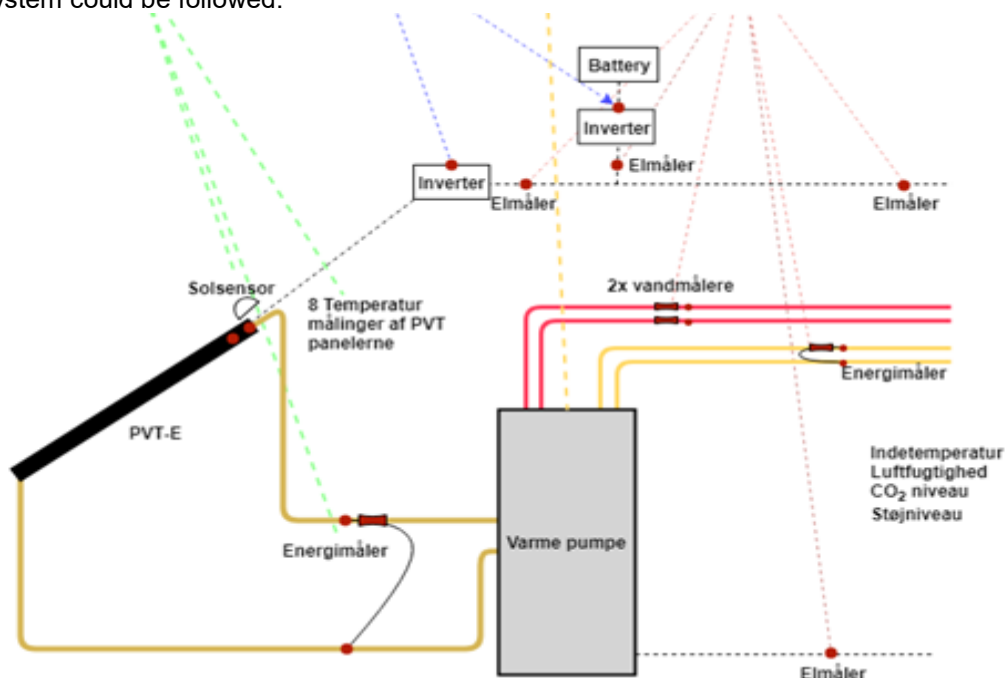
Figure 1-1 shows a schematic sketch of the system with the applied measurement equipment. The space heating demand, the domestic hot water consumption, the electricity consumption, the heat and electricity production of the panels, the solar radiation, the outdoor temperature, the indoor climate and system temperatures were measured. In this way, the detailed operation of the system could be followed.

Figure 1-1 Schematic sketch of PVT system with monitoring equipment.

The system consist of 16 PVT-E modules with a total gross area of 40 m² and 2 PV modules with a total gross area of 5 m² on the south facing roof and 20 PV modules with a total gross area of 50 m² on the north facing roof. The panels are connected to a 7.5 kWh Fronius battery and a modulating Danfoss Varius Pro+ heat pump of 3-12 kW.

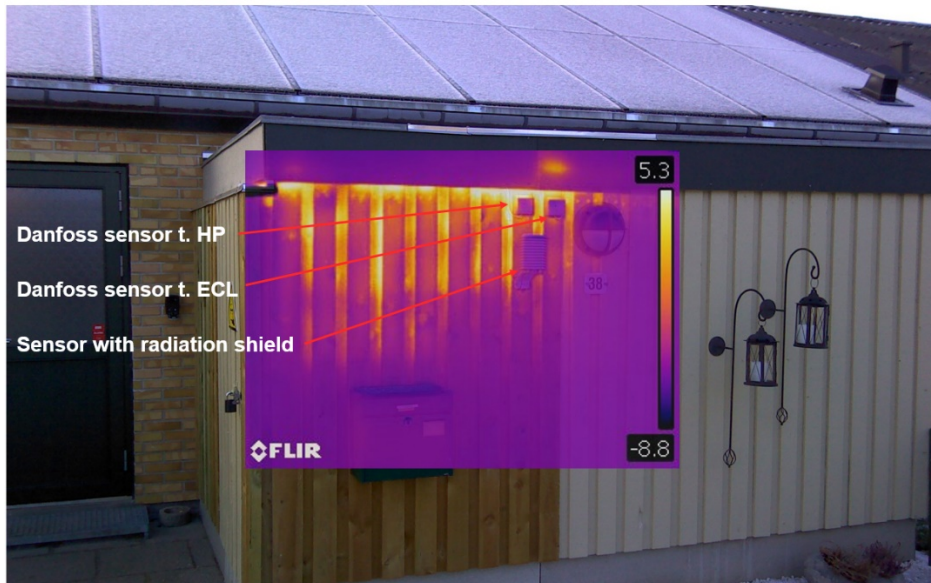
The outdoor temperature is measured in order to determine the performance. It was detected early on that the temperature measurements from the Danfoss sensors was recording too high temperatures because of influence from the other installations in the shed. An additional sensor was installed with a radiation shield, see Figure 2-1. The pictures also shows an infra-red photo of the shed showing the heat interference from the installations onto the Danfoss sensors.

Figure 2-1 Placements of the Danfoss sensors and the new sensor with radiation shield.

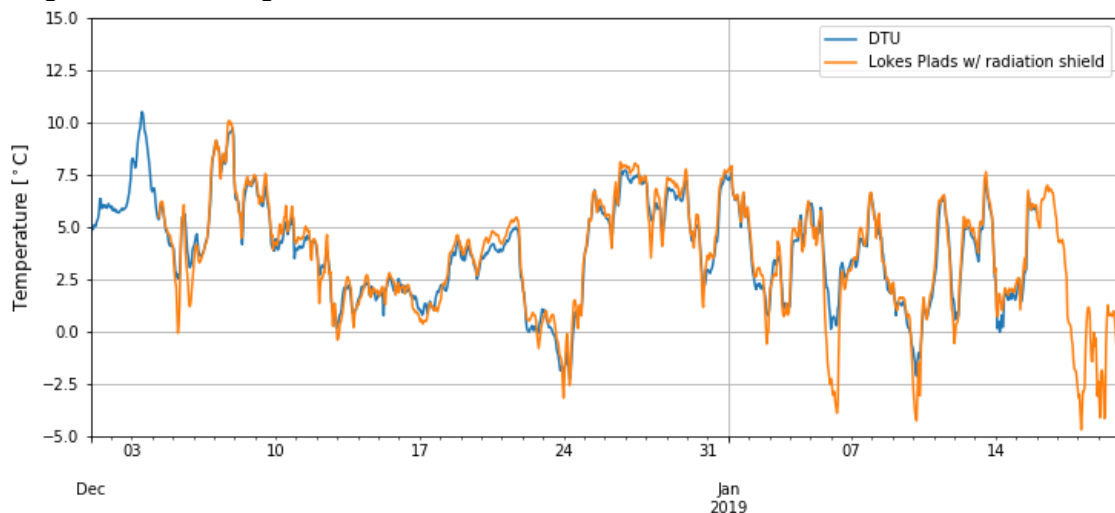
The measurements with the sensor with the radiation shield is compared with measurements from DTU in Kgs. Lyngby in order to validate the measurements. The comparison can be seen on Figure 2-3, where a good correlation is obtained.

Figure 2-2 Comparison between outdoor temperature measurements in Stengården and DTU Kgs. Lyngby.

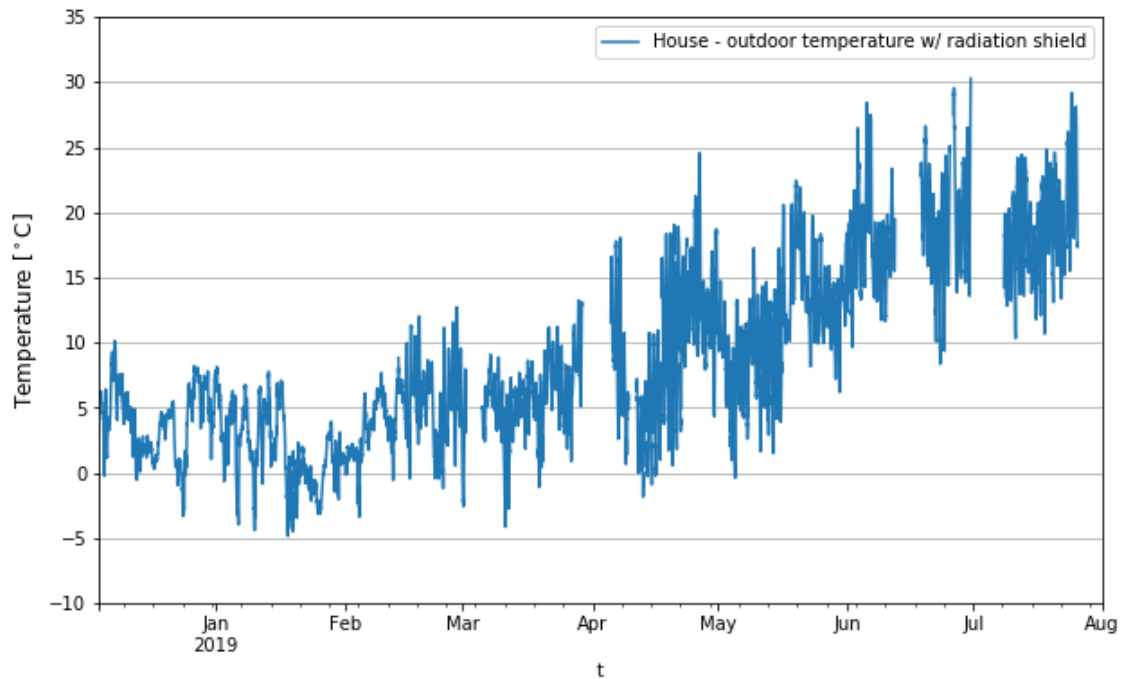
The outdoor temperature measured during the whole measuring period can be seen on Figure 2-4 with increasing temperatures in the summer period.

Figure 2-3 Outdoor temperature during the measuring period.

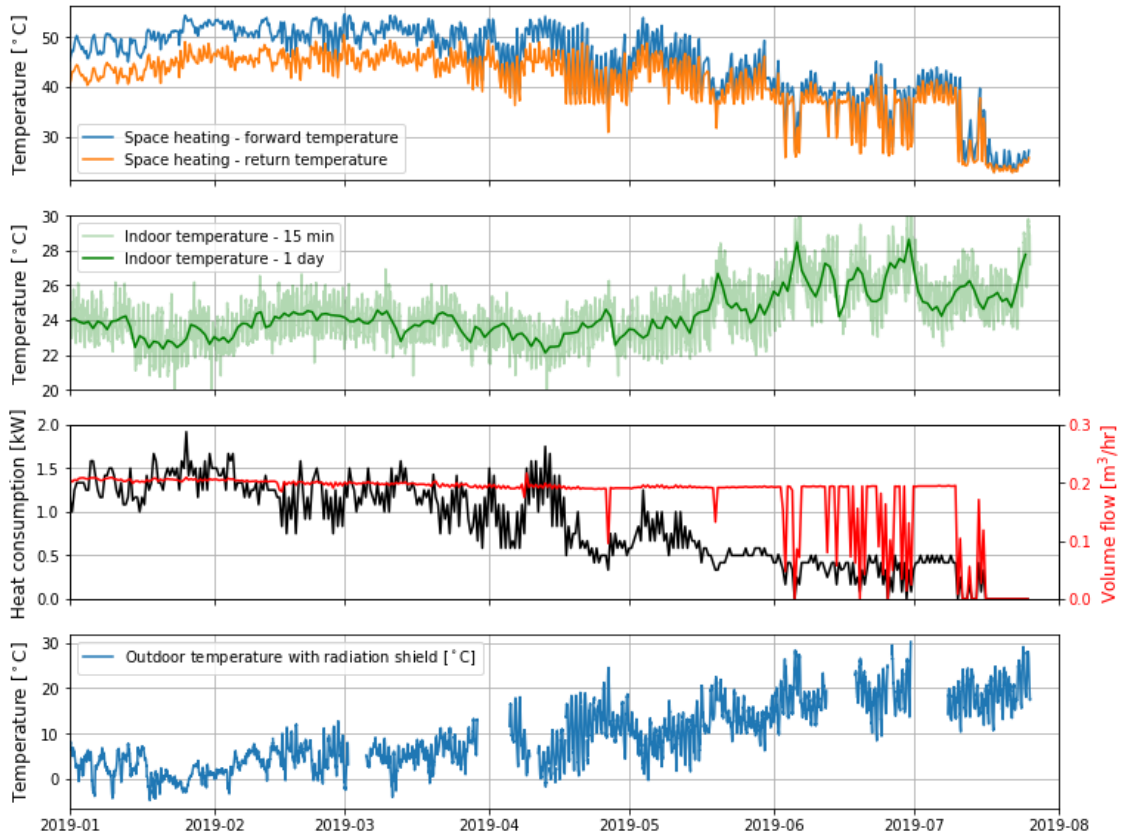
The inlet and outlet temperatures for space heating system, the indoor temperature, the outdoor temperature and the heat consumption can be seen on Figure 3-1. It is seen that the space heating demand is very low compared to the size of the heat pump. The highest space heat demand is lower than 2 kW, while the lowest power of the heat pump is 3 kW. The heat pump is therefore strongly oversized resulting in very short operation periods and relatively low efficiency of the heat pump. In this connection it should be noted, that no small heat pumps suitable for the low space heating demand were available on the market at the start of the project.

Figure 3-1 Temperatures and energy for space heating in the house in Stengården.

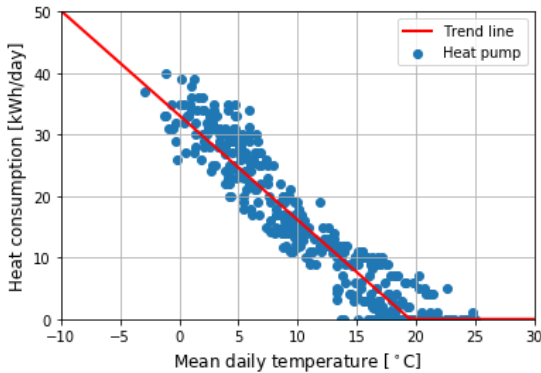
The daily heating demand in the house is dependent of the mean daily outdoor temperature, as it is seen on Figure 3-2.

Figure 3-2 Daily heating consumption as a function of the mean daily outdoor temperature.
